SURFACE PREPARATION PRODUCTS

CASE HISTORY

VpCI® CorVerter™ /VpCI®-368/VpCI®-386/VpCI®-426/VpCI®-705/Rawn Engine Degreaser/Bullfrog Fast Wax

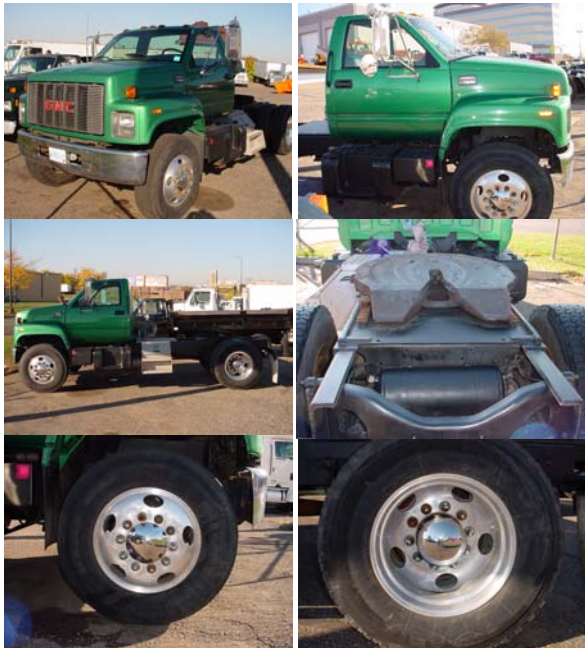
Cortec® Advanced Films division owned a truck that needed protection. Due to the harsh climate of central Minnesota, and the extreme amount of deicing compounds used on the road, portions of the truck had corroded considerably.

A team of Cortec® employees were asked to rehabilitate the truck and enhance its appearance. The areas in need of attention were the chrome wheel wells, the fifth wheel attachment/ under carriage, the engine compartment, and the overall visual exterior of the truck.

Using VpCI®-426 to remove corrosion on the vehicle and Bullfrog fast wax for short-term protection the wheels and body of the vehicle were restored to an almost new state. Rawn engine degreaser cleaned the engine, and the undercarriage was coated with VpCI®-386. The fifth wheel attachment and under carriage was then coated with VpCI® CorVerter™ and VpCI®-386 to give an attractive and resilient finish that will prohibit corrosion for years to come.
